- 1.1 MPTrees have prepared this report on behalf of Rufford Parish Council who wish to understand the risk of harm or damage to people or property associated with trees at Rufford Recreation Ground, Flash Lane, Rufford and The Scout Field on the opposite side of the A59 Liverpool Road.
- 1.2 Trees at the Recreation Ground and Scout Field have been surveyed previously by West Lancashire Borough Council in 2016 and 2020. This report has used the survey information and plan provided by West Lancashire Borough Council with their permission.

Rufford Parish Council  
Recreation Ground & Scout Field  
Tree Hazard Survey & Report  
M Potier  
18/06/2021

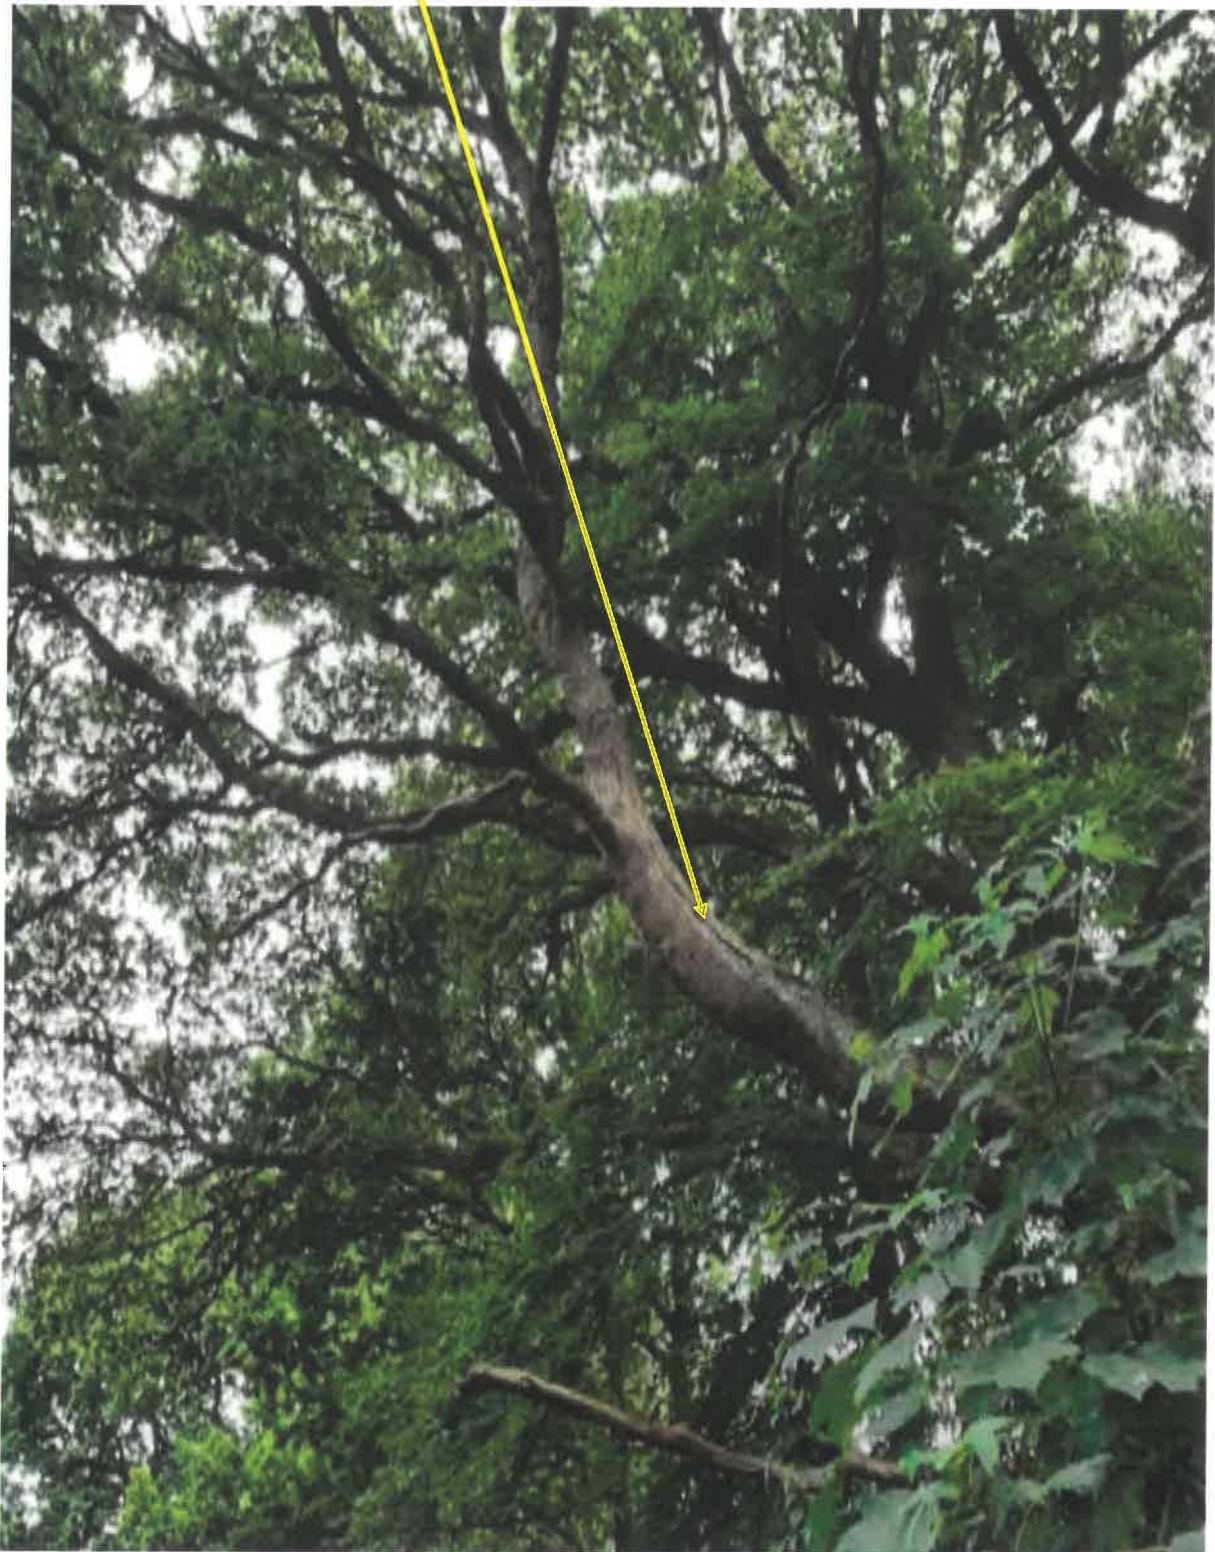
- 4.11 Tree T6 is a mature Oak that has a large upsweeping primary branch that extends over the eastern boundary of the Recreation Ground and the A59 Liverpool Road. There is a large vertical split in the limb where it starts to bend upwards. There is a high probability the limb will break and fail as the split opens, probably in high winds and/or very wet weather which will increase the weight of the limb. If/when the limb breaks there is a high risk of harm to users of the A59 Liverpool Road. See photograph 1 at appendix 4 for detail.

| GRP REF | TREE REF | SPECIES | AGE | HT | DBH | VITALITY | COMMENTS & RECOMMENDATIONS | MGT CAT | RISK ASSESSMENT OF | ROH |
|---|---|---|---|---|---|---|---|---|---|---|
| | T6 | Oak | M | 16 | 500 | N | Large upsweeping heavy lateral over boundary with vertical split. Remove limb back to main stem as soon as possible. Risk of branch splitting and falling onto A59. Marked with orange biodegradable dot at breast height. | 1,8 | Branch failure over road. | 1:5K |

Photographs 1 - Detail of vertical split in large primary branch extending over A59.

- 5.1 It is recommended that consideration be given to the tree works detailed in the Management Recommendations at appendix 1.
- 5.2 With regard to tree T6 it is further recommend that this work is carried out as soon as is practicably possible to mitigate the risk of harm.

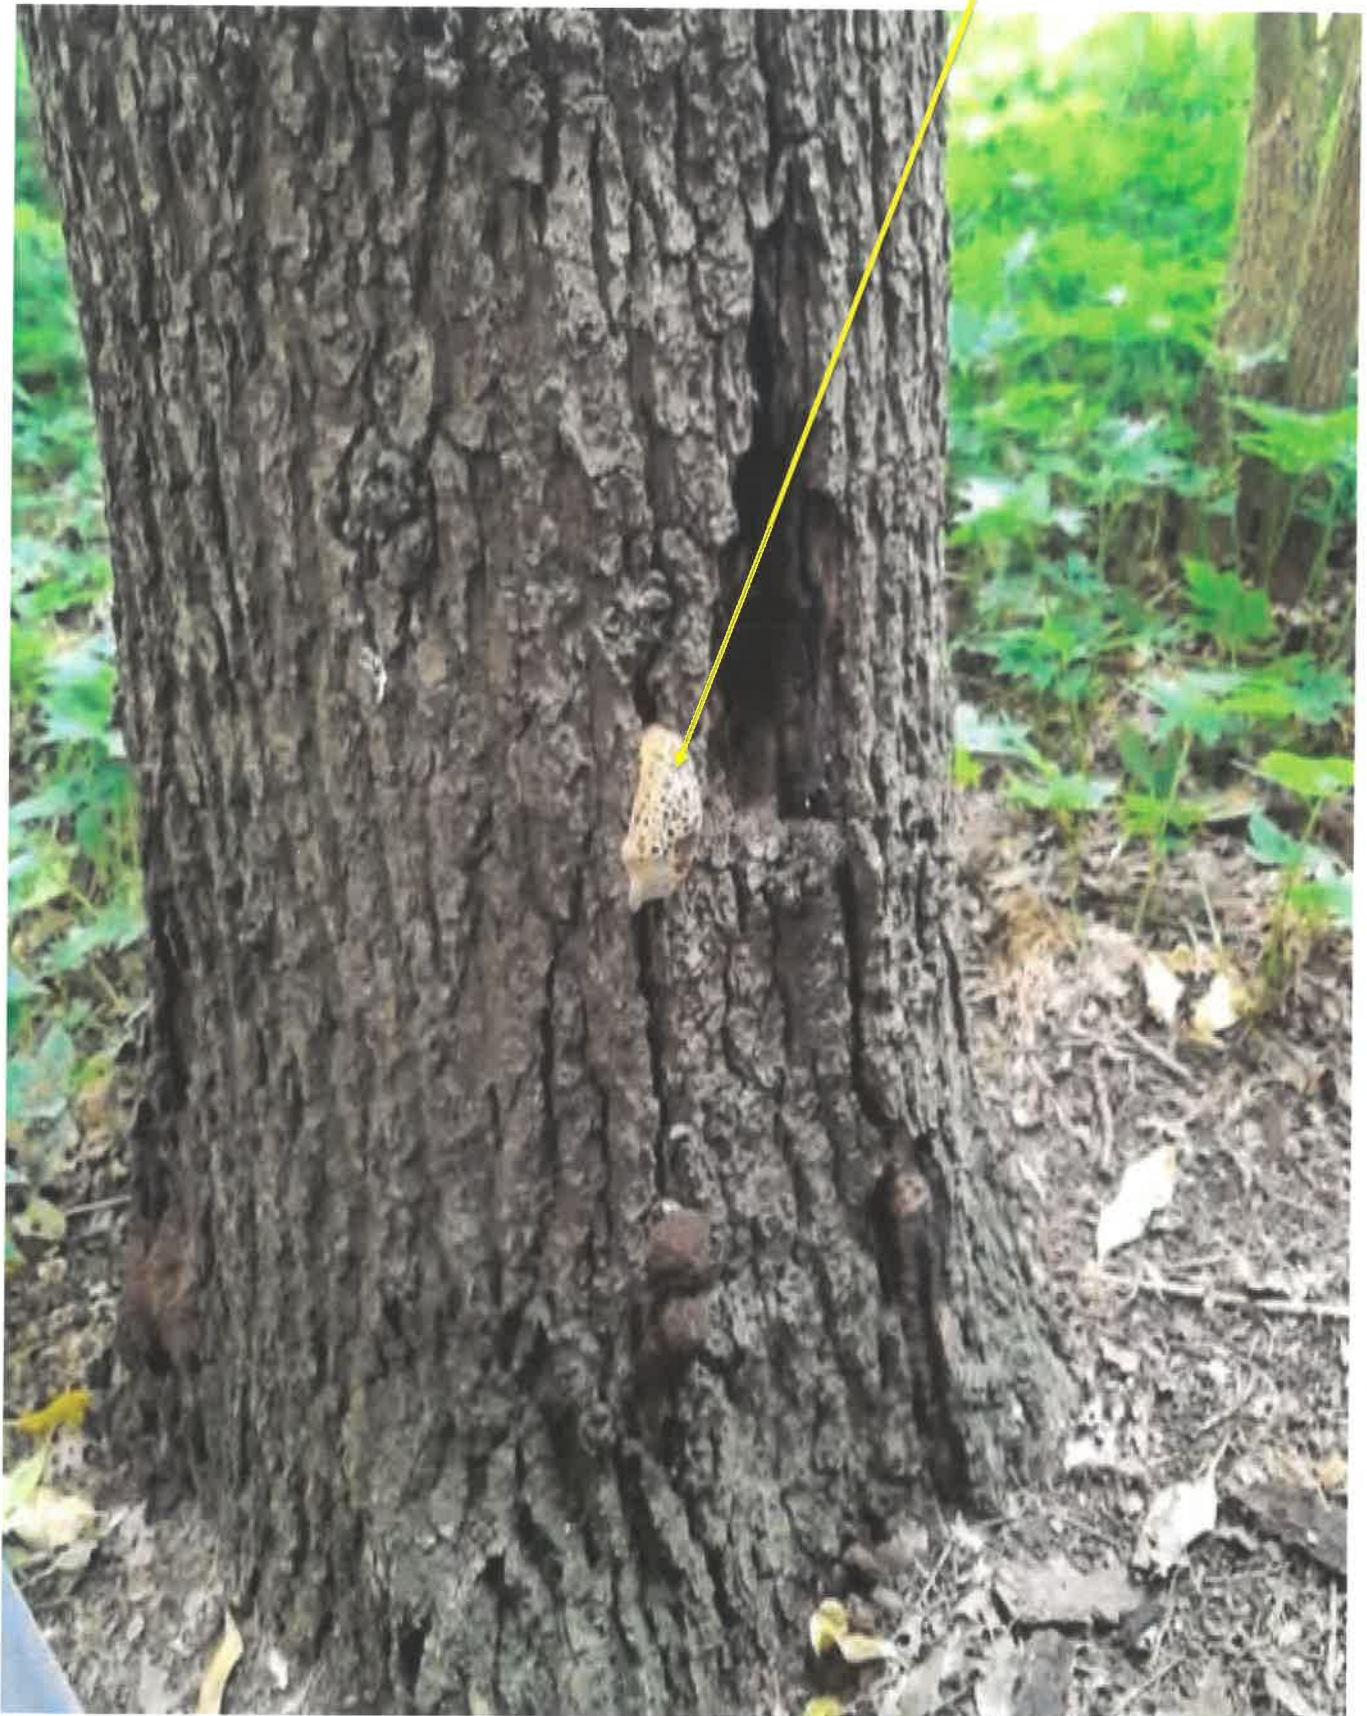
| GRP REF | TREE REF | SPECIES | AGE | HT | DBH | VITALITY | COMMENTS & RECOMMENDATIONS | MGT CAT | RISK ASSESSMENT OF | ROH |
|---|---|---|---|---|---|---|---|---|---|---|
| | T1 | Oak | M | 16 | 300 | R | Tall thin canopy all to south west over neighbours garage ganoderma at base to south and stem wound with decay. Retire to mitigate increase in risk levels over time. | 2,6,9 | Stem or branch failure over neighbouring property. | 1:300K |

Photograph 2 – Detail of base of T1 to east, showing stem wound and *Ganoderma* bracket.

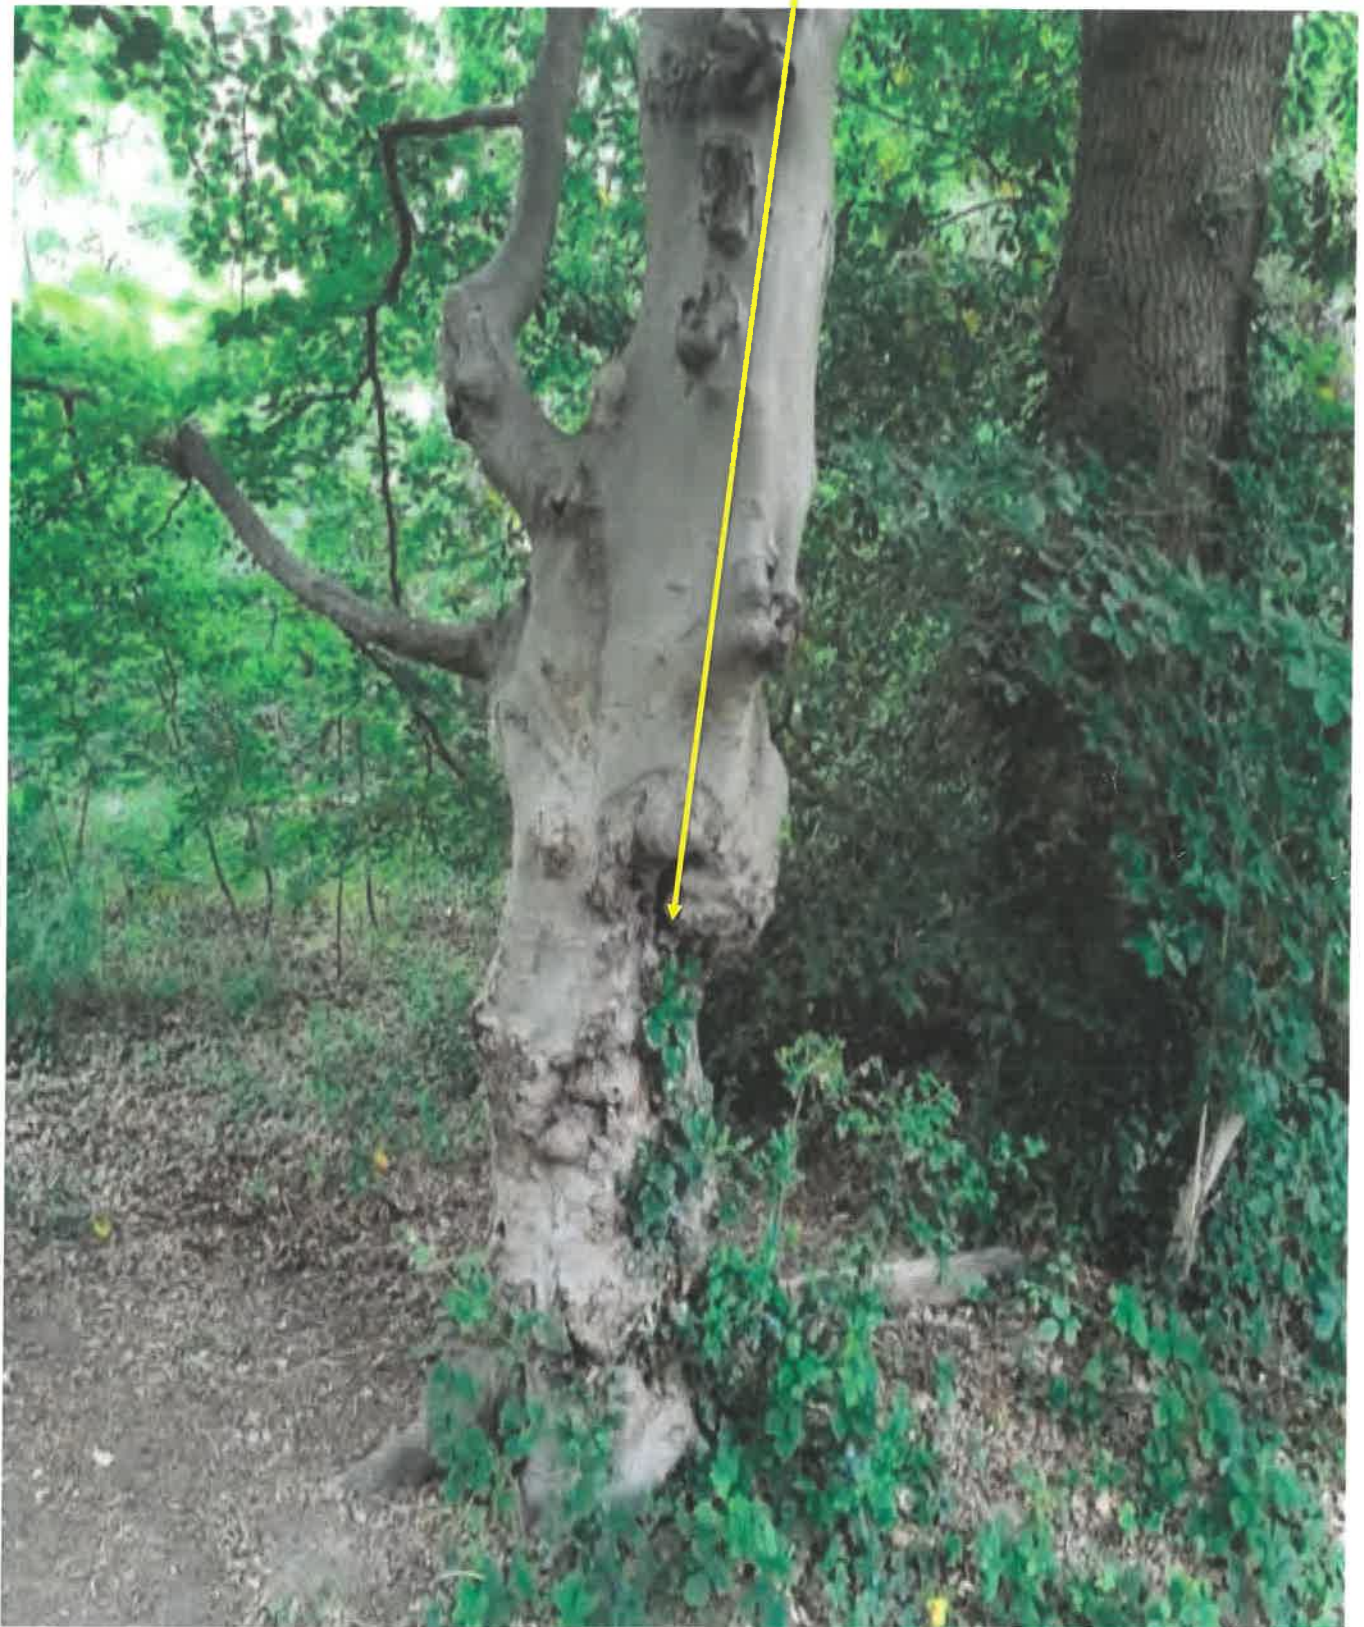
- 4.21 Tree T1 is a mature Oak tree located next to the southern boundary of the Recreation Ground and adjacent neighbouring property. It has decay at its base with the fungal pathogen *Ganoderma* present. There is an increased probability of stem failure over neighbouring property and as the decay in the main stem develops the probability will increase, increase the risk of harm or damage to property. See photograph 2 at appendix 4 for detail.
- 4.22 Tree T7 is an early mature beech tree that has extensive *Stereum* canker rot of the base of its main stem caused by the fungus *Stereum rugosum*. There is an increased probability of stem snap and failure and a risk that the stem will fail to the east over the A59. See photograph 3 at appendix 4 for detail.

| GRP REF | TREE REF | SPECIES | AGE | HT | DBH | VITALITY | COMMENTS & RECOMMENDATIONS | MGT CAT | RISK ASSESSMENT OF | ROH |
|---|---|---|---|---|---|---|---|---|---|---|
| | T7 | Beech | EM | 15 | 400 | R | Extensive stem canker at breast height, risk of stem snap. Reduce to safe standing height e.g. 3-4m. Marked with orange biodegradable dot at breast height. | 2,9 | Stem failure over road. | 1:500K |

Photograph 3 – Detail of base of T7 with extensive Stereum canker rot.
